# Manhole Inspection Summary

Manhole # S37EE\_035MH

Insp Date: **3/23/07 10:04 AM**

**Location** Address: **701 MURA ST**

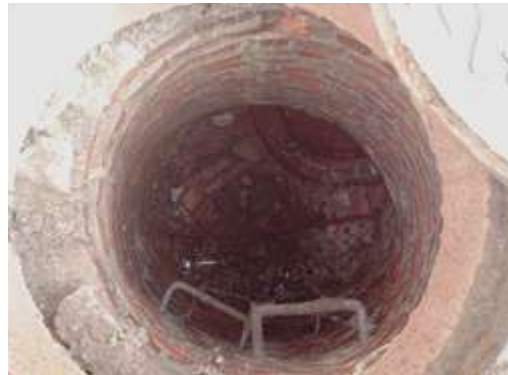
Top View

**Bench** ☒ Exists Material: **Brick** ☐ Parged ☒ **Debris** (not Condition related)

Bench debris.

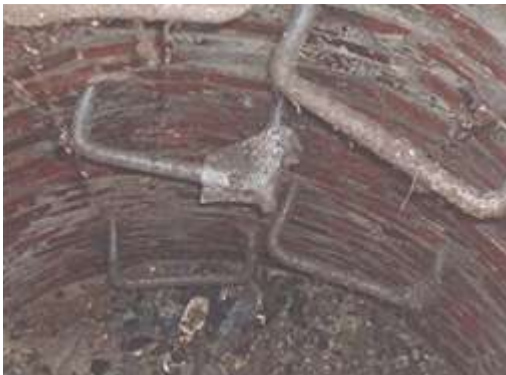
Defect

Infiltration: ☐ None ☐ Joint ☐ Cracks ☒ **Mortar** ☐ Roots ☒ **Wall**

**Surcharge** ☒ **Evidence Of Surcharge** Depth: **3** (ft.) ☐ Active Surcharge Present

Corbel and Barrel infiltration. Evidence of surcharge - Bench debris.

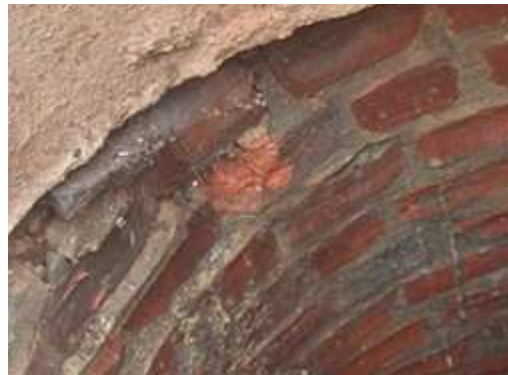
Defect

Corbel infiltration.

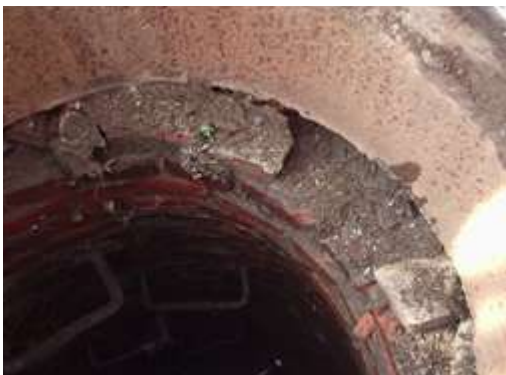
Defect

**Frame** Offset: **3** (in.) Condition: ☐ Sound ☐ Cracked ☒ **Leaks**

Condition: ☐ Sound ☐ Cracked ☐ Root Intrusion ☒ **Loose Brick** ☒ **Deteriorated**

Infiltration: ☐ None ☒ **Joint** ☐ Cracks ☒ **Mortar** ☐ Roots ☐ Wall

Frame leaks. Frame offset. Adjustment deterioration, loose brick and infiltration.

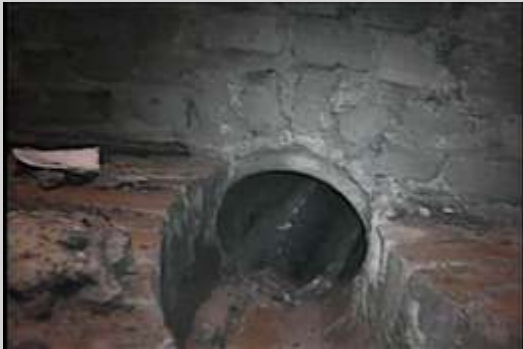
### 8 in. Circular Gravity Sewer Pipe Out @ 12 O'Clock

Infiltration: **Evidence** Pipe Seal Cond: **Unknown**

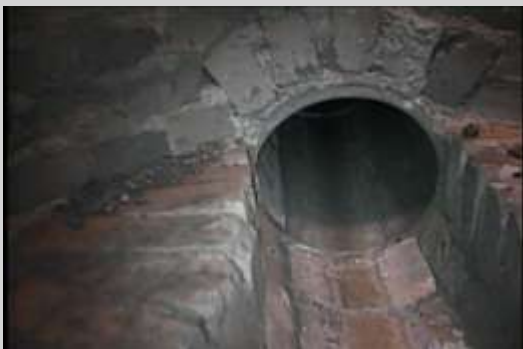
### 8 in. Circular Gravity Sewer Pipe In @ 3 O'Clock

Infiltration: **Evidence** Pipe Seal Cond: **Unknown**
